# Manhole Inspection Summary

Manhole # S09EE2013MH

**Location** Address: **6000 GREEN MEADOW PKWY** Cross Street: **WESTERN RUN DR**

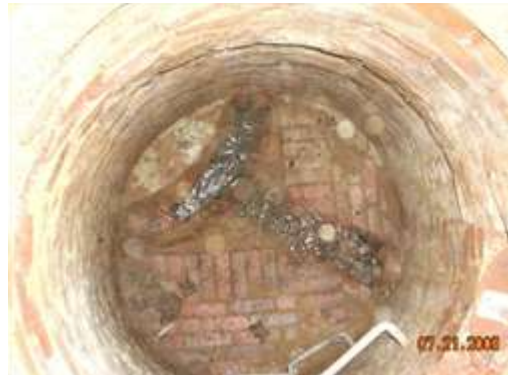
Top View

Bench and Channel debris.

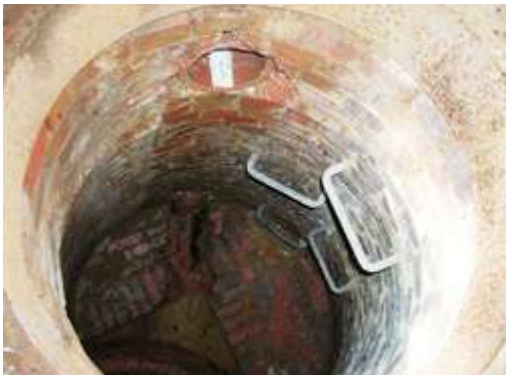
Defect

**Frame** Offset: **0** (in.) Condition: ☐ Sound ☐ Cracked ☒ **Leaks**

**Chimney / Frame Adjustment** ☒ Exists Material: **Brick** ☐ Parged Height: **9** (in.)  
Condition: ☐ Sound ☐ Cracked ☐ Root Intrusion ☐ Loose Brick ☒ **Deteriorated**  
Infiltration: ☐ None ☒ **Joint** ☐ Cracks ☒ **Mortar** ☐ Roots ☐ Wall

**Corbel** Material: **Brick** ☐ Parged Type: **Concentric/Eccentric**  
Condition: ☐ Sound ☐ Cracked ☐ Root Intrusion ☐ Loose Brick ☒ **Deteriorated**  
Infiltration: ☐ None ☐ Joint ☐ Cracks ☒ **Mortar** ☐ Roots ☒ **Wall**

Frame leaks. Adjustment and Corbel deterioration and infiltration. Barrel infiltration.

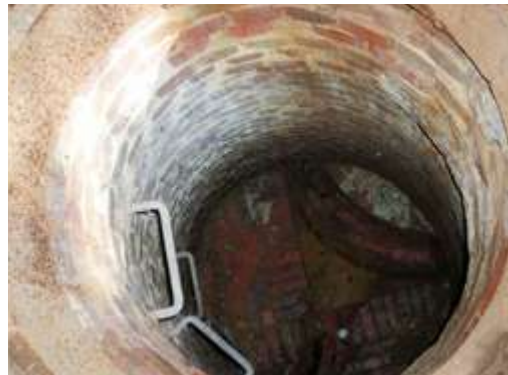
Defect

Frame leaks. Adjustment and Corbel infiltration - other side.

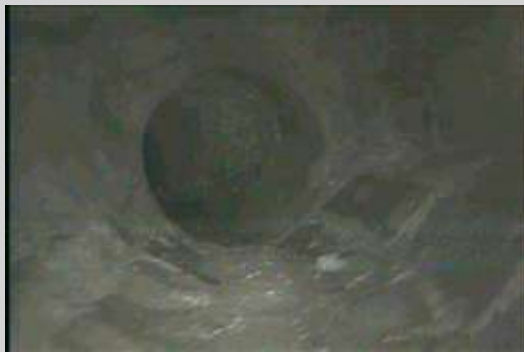
### 8 in. Circular Gravity Sewer Pipe Out @ 12 O'Clock

Infiltration: **Evidence** Pipe Seal Cond: **Unknown**

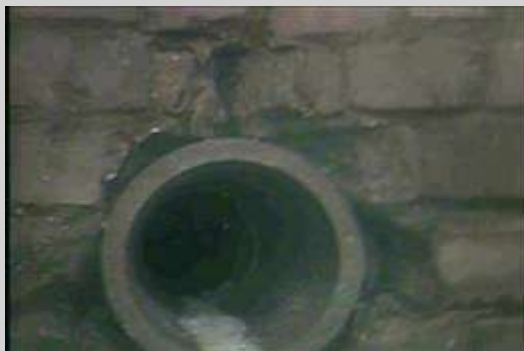
### 6 in. Circular Gravity Sewer Pipe In @ 4 O'Clock

Corbel deterioration and infiltration.

Infiltration: **Evidence** Pipe Seal Cond: **Broken**

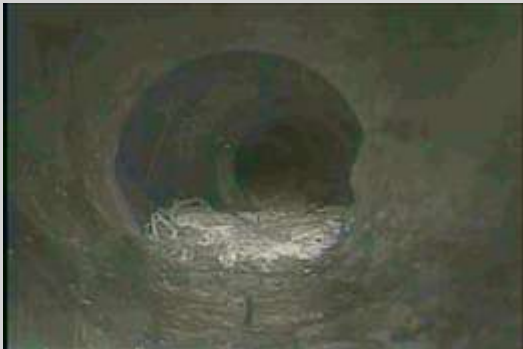
8 in. Circular Gravity Sewer  
Pipe In @ 9 O'Clock

Deposits: ☐ None ☒ **Mud** ☐ Sludge ☒ **Debris** ☒ **Grease**

Silt Depth: **1** (in.) Deposits Extent: **Light**

Infiltration: **Evidence** Pipe Seal Cond: **Unknown**
